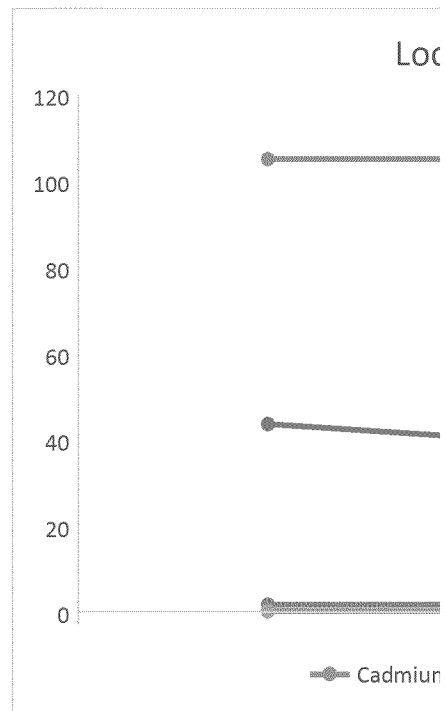
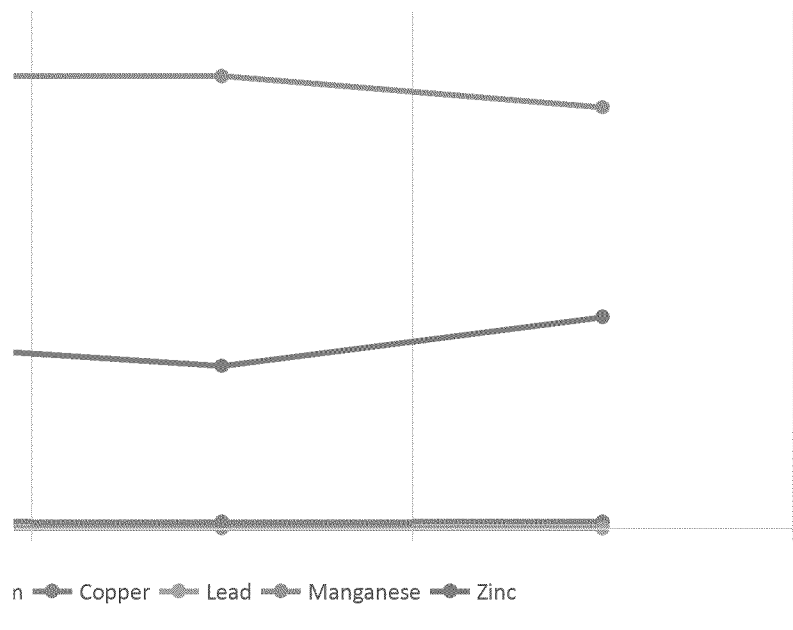
Location: 32nd Street Bridge

ocation ID	Date Sampled	Cadmium	Copper	Lead	Manganese	Zinc
32nd St Br	8/5/2015	0.178	1.7	0.24	105	43.5
32nd St Br	8/6/2015	0.16	1.56		105	37.8
32nd St Br	8/6/2015	0.19	1.62	0.115	97.8	49.1

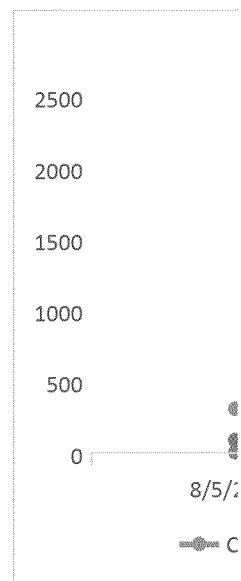
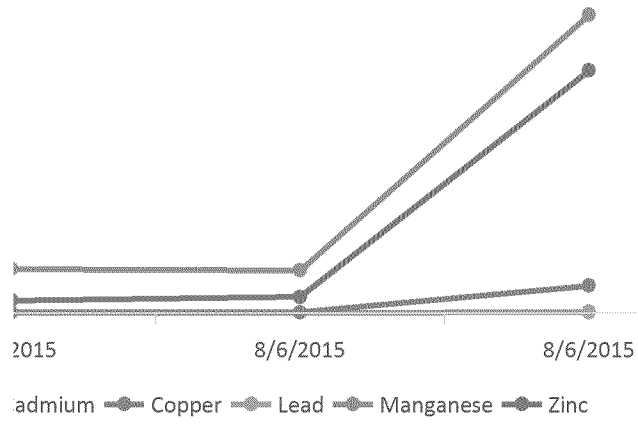
Location: Bakers Bridge

Location ID	Date Sampled	Cadmium	Copper	Lead	Manganese	Zinc
Bakers Bridge	8/5/2015	0.353	2.28		306	85.8
Bakers Bridge	8/6/2015	0.336	1.88		296	110
Bakers Bridge	8/6/2015	5.32	189	1.56	2090	1700
